**A RESOLUTION OF THE VILLAGE OF FRANKLIN PARK, COOK COUNTY,
ILLINOIS DECLARING AS SURPLUS PROPERTY THE VILLAGE OWNED
BUILDING AND PARCEL OF REAL PROPERTY AT 3335 SCHIERHORN COURT
AND AUTHORIZING VILLAGE STAFF TO MARKET THE PROPERTY FOR
DEVELOPMENT AND DIRECT THE VILLAGE CLERK TO MAKE A COPY
OF THE APPRAISAL OF THE PROPERTY AVAILABLE TO ANY PARTY**

Exhibit A

Exhibit B

Subject Photos

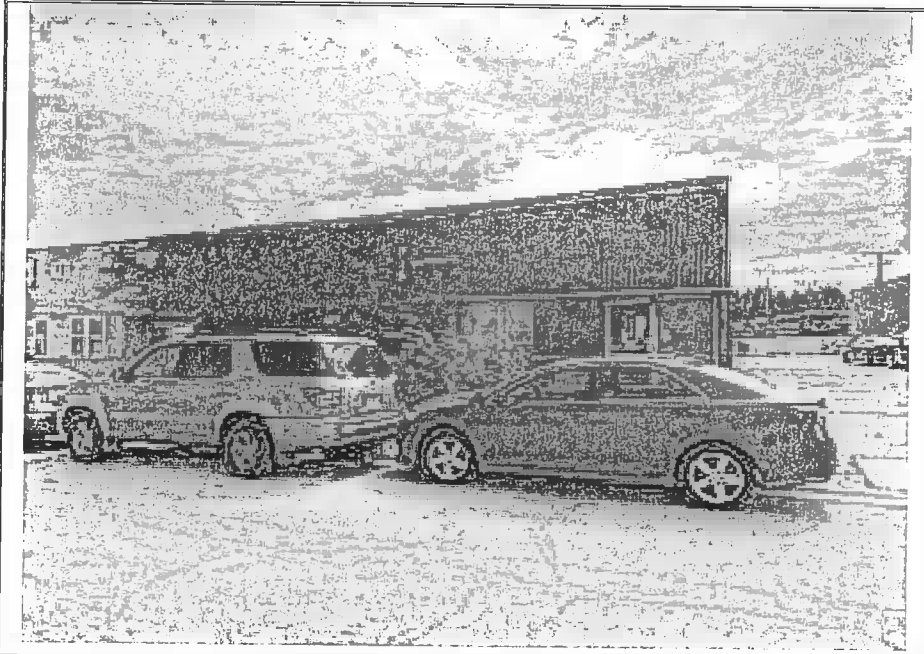
FRONT (SOUTH) ELEVATION

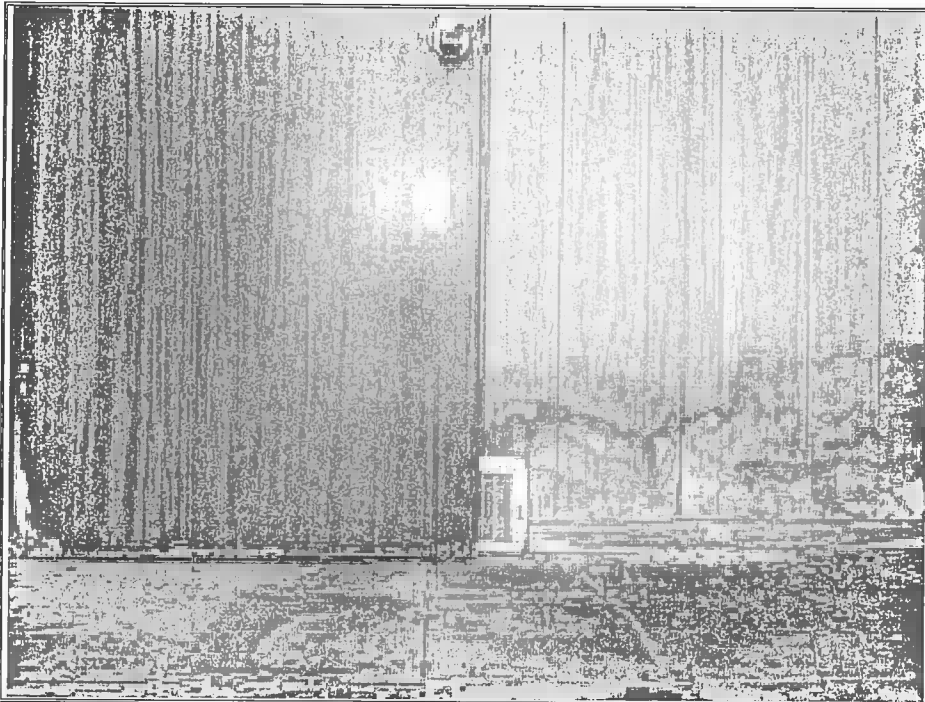
The interior is mostly open warehouse area, though there is an office area (est. at 10% of GBA) with worn and dated finish (older and worn tile and paneling with water marks) in the front. The front of the lot has overgrown landscaping. There is a driveway along the side (south) lot line which leads to a paved area in the rear, which is in need of resurfacing. The façade has face brick in average condition, while the remainder has common brick in need of substantial tuckpointing, and brick replacement in areas. Overall, it is in fair to poor condition.

FLOOR AND LOWER WALL DETAIL IN OFFICE AREA

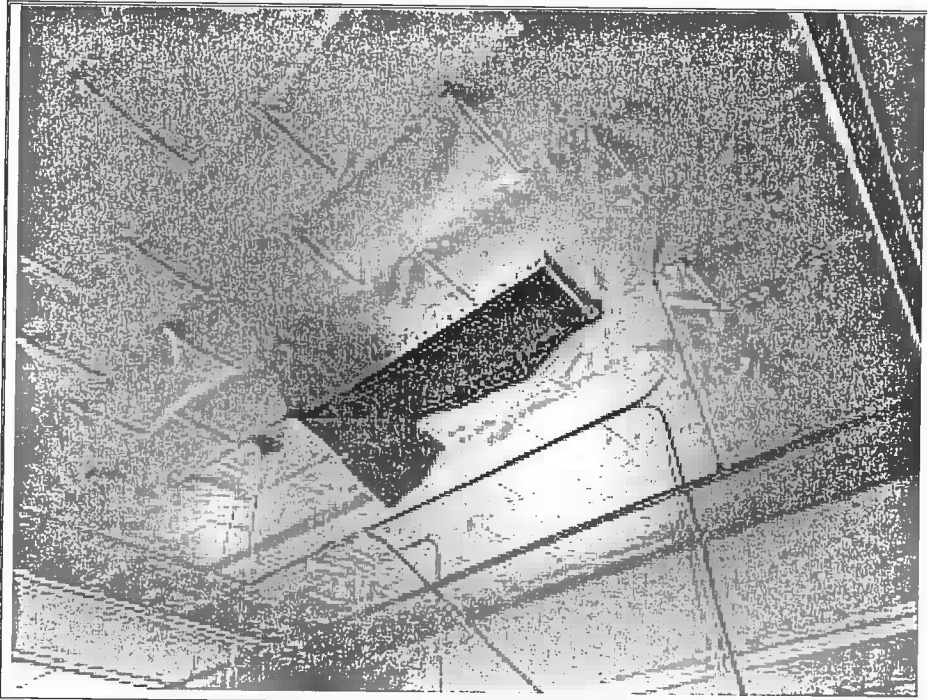
WAREHOUSE CEILING

Deferred Maintenance: The subject building has been vacant for over ten years and is an older light industrial building with significant deferred maintenance. There is a small finished area in the front of the building with a vestibule, reception area, private office and a single-user washroom. The finish in the entry area consists of older, worn and damaged tile, older paneling and drywall ceilings with fluorescent strip lighting. There was black staining on the base of the paneling and drywall in areas, possibly mold. There are some holes in the drywall walls and the paint is peeling significantly in the washroom. There is evidence of water damage. The office area is in need of a gut renovation. The majority of the building is warehouse space with concrete floors, concrete block walls and a thin covering over the roof deck. There is a ceiling suspended, gas fired unit heater, though it is reportedly not functional. There is some trash on the floor of the warehouse, along with some steel drums and other materials and equipment. There were some puddles on the ground indicating roof leaks. The building is reportedly in need of a new roof (tear off) and the contractors estimate is \$77,455.

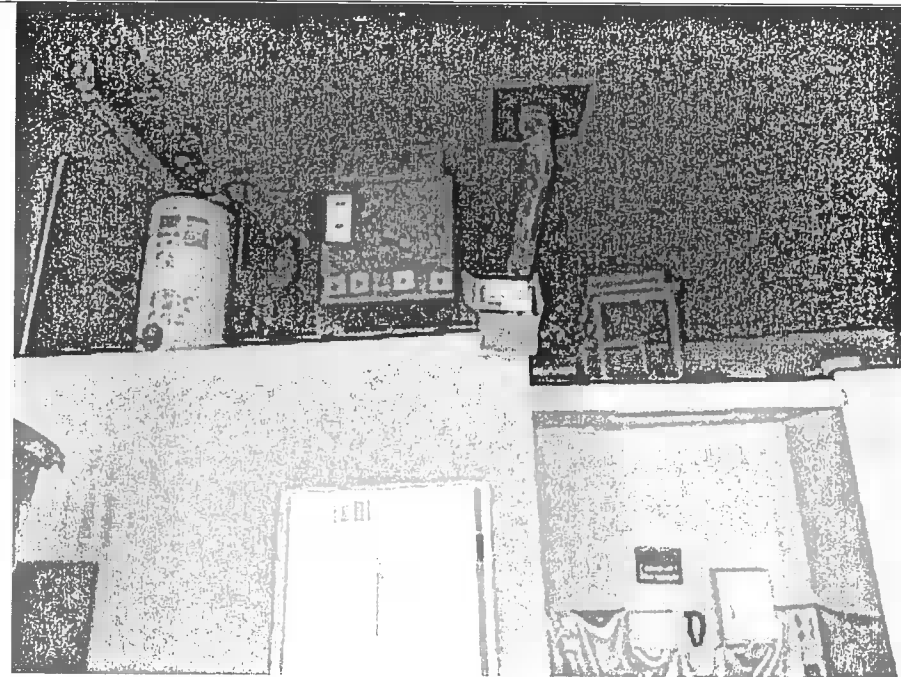
Heating:	Gas forced warm air and CAC in the office and a ceiling suspended, gas fired unit heater in the warehouse area. All mechanicals are reported to be in need of replacement.
Cooling:	Central AC in office area only - unit reported to be past its economic life and in need of replacement
Electrical:	Circuit breaker panel; reported to require new electrical service
Plumbing Condition:	Reported to be in need of modernization

FURNACE AND HOT WATER HEATER ABOVE OFFICE AREA
